Subject: Summary of Intrusive Activities – Utility Pole Installation  
Patchogue Former MGP Site  
NYSDEC Site No. 1-52-182  
Village of Patchogue, Suffolk County, New York

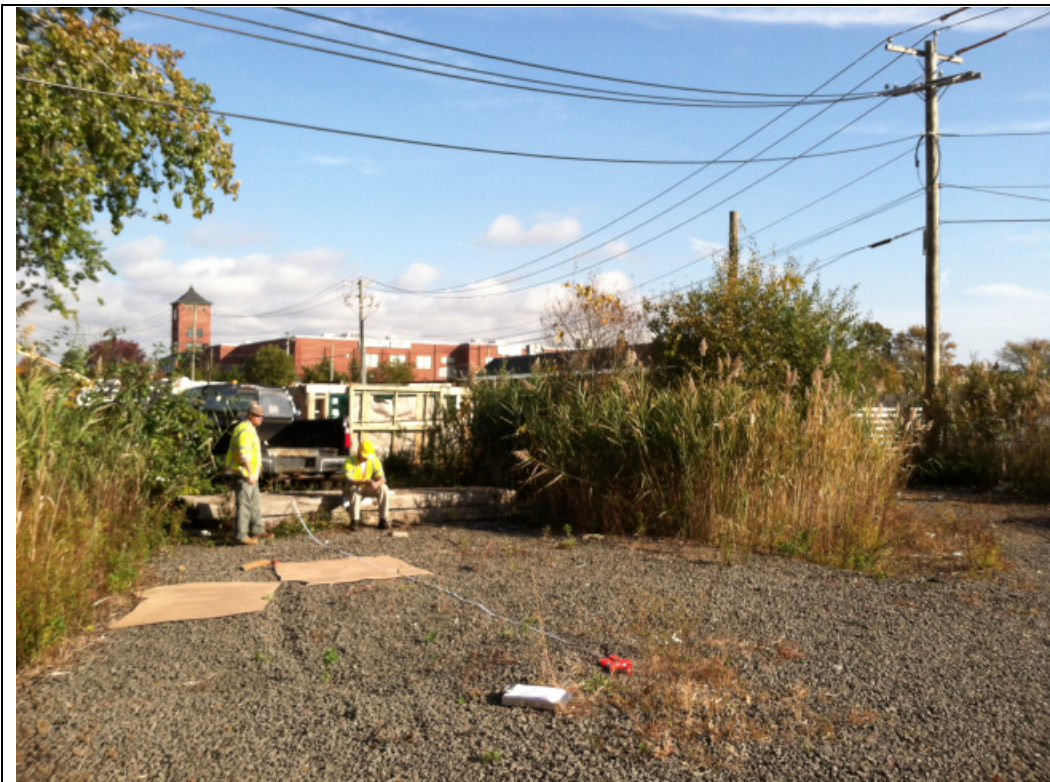
Photograph #1 – Visual reconnaissance of work area prior to intrusive activities.

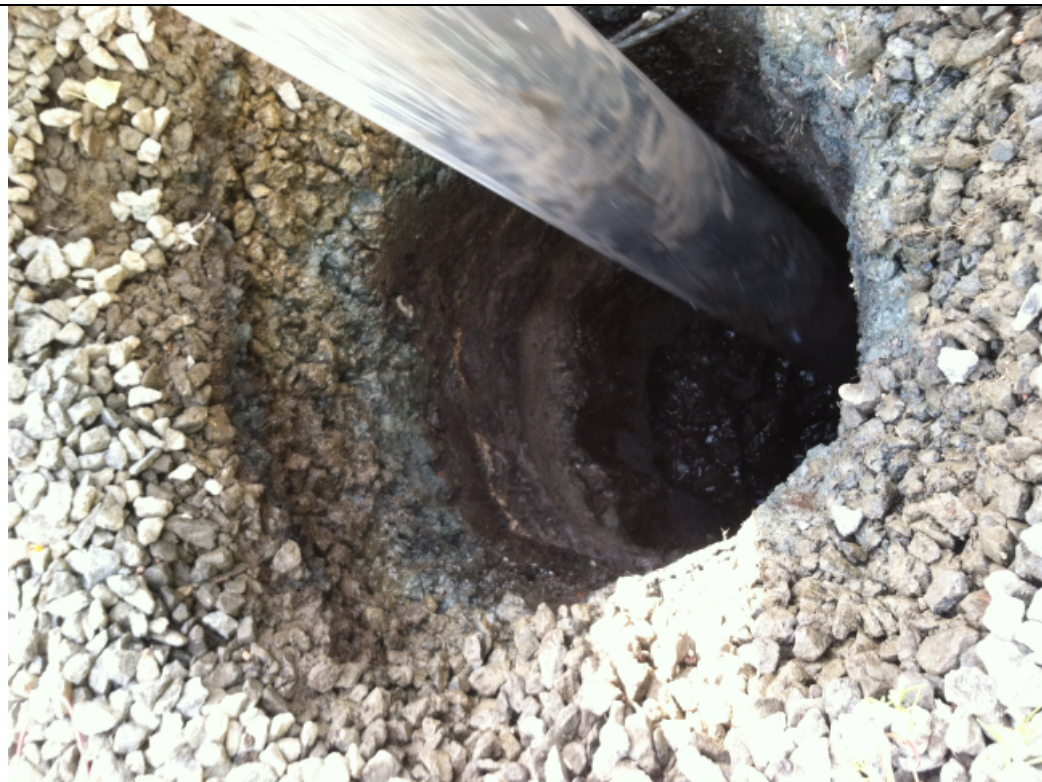
Photograph #2 – Vacuum soil extraction of an approximately 18-inch diameter hole.

The utility pole installation process included vacuum soil extraction of an 18-inch diameter hole to a depth of approximately six-feet below ground surface (bgs). Saturated soils were encountered at a depth approximately two-feet bgs. Therefore, a corrugated plastic pipe was installed to stabilize to sidewalls of the hole and enable advancement to the target depth of six-feet bgs. After reaching the target depth of six-feet bgs, PSEG Long Island installed the utility pole and backfilled the annular space between the pole and the sidewalls of the hole with backfill routinely used by PSEG Long Island for utility pole installation activities. A photographic log documenting the vacuum extraction and utility pole installation work is attached for reference.

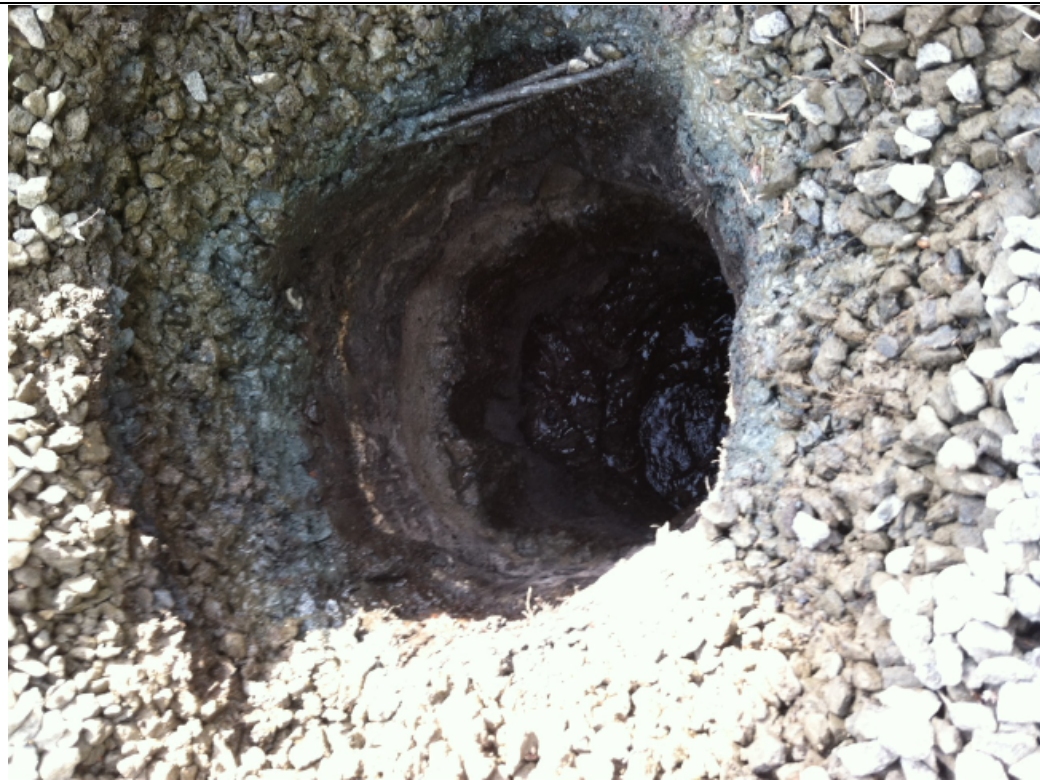
Photograph #3 – View of sidewalls and bottom of hole prior to utility pole installation. Note the groundwater seepage into the hole. Groundwater was encountered at a depth of approximately 2 feet below ground surface.

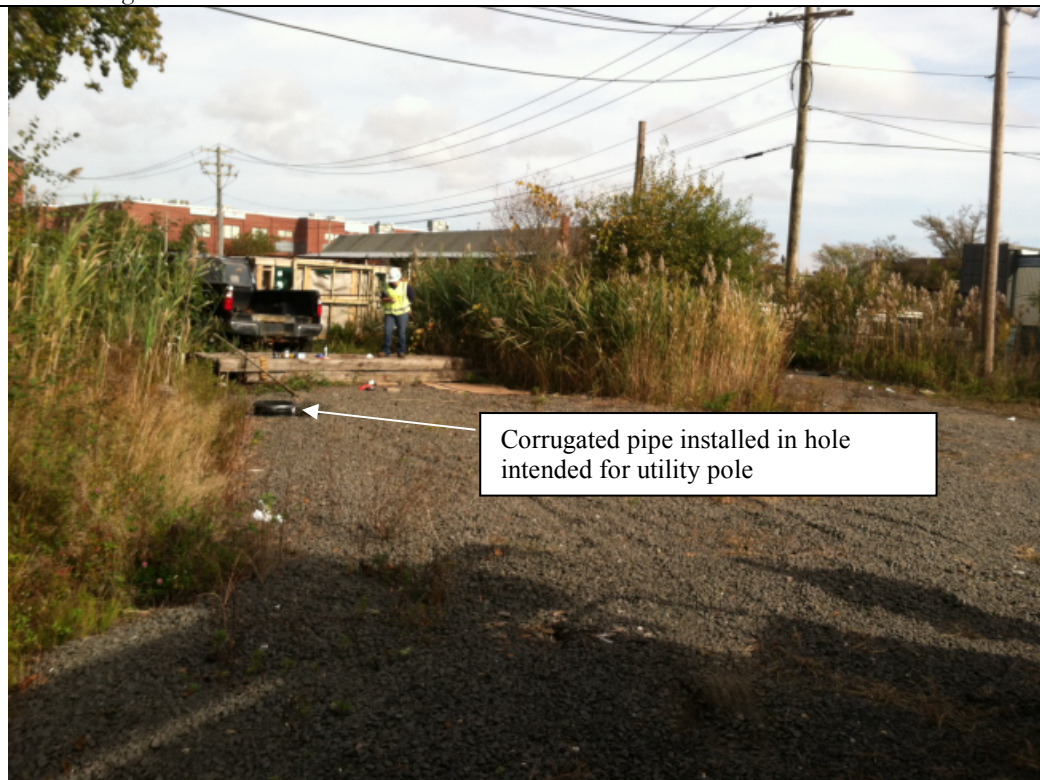
Corrugated pipe installed in hole  
intended for utility pole

Photograph #4 – View of work area following vacuum soil extraction to target depth and subsequent installation of corrugated plastic pipe intended to stabilize sidewalls of hole.

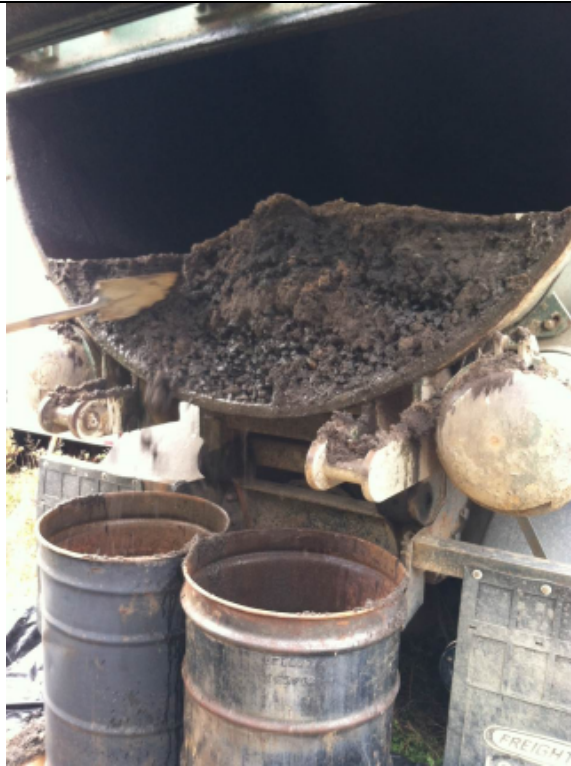
Photograph #5 – Transfer of wastes from the vacuum soil extraction unit into 55-gallon drums to facilitate off-site disposal.

Wastes derived as part of the implementation of the utility pole installation activities included soils and groundwater generated from the vacuum extraction activities. The soils and liquids were transferred from the vacuum soil extraction unit into DOT-approved 55-gallon drums. The drums were labeled to identify their contents, origin and to provide the contact information for the National Grid Project Manager. The drums were inventoried, including photographs of the drums, to facilitate pick-up and off-site disposal of the wastes.

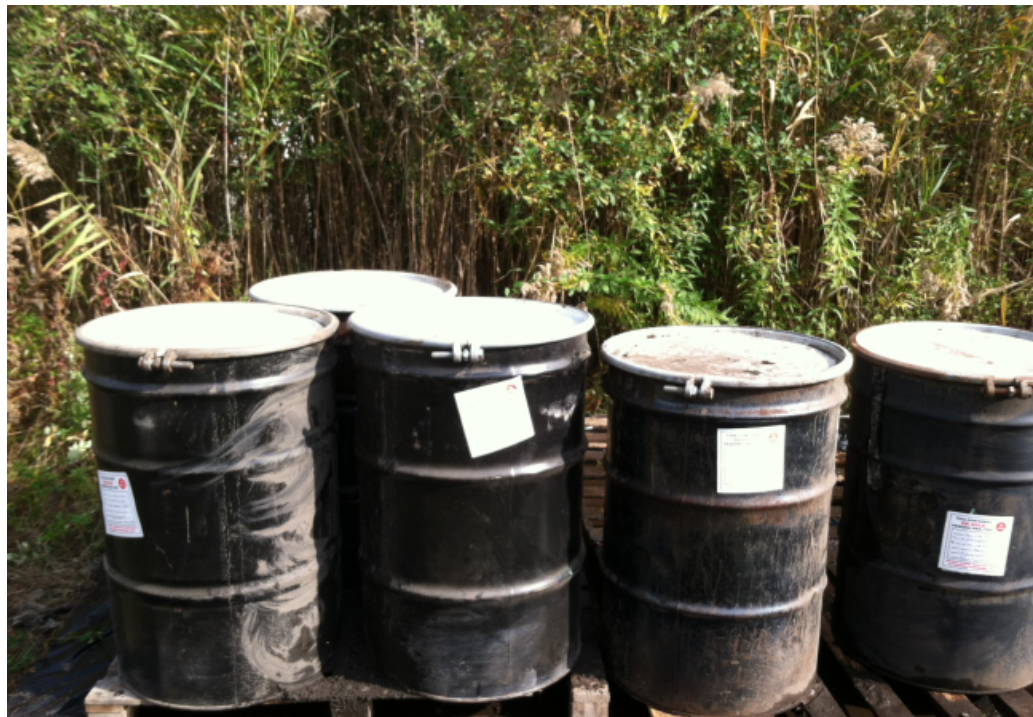
Photograph #6 – Wastes generated during the utility pole installation activities. Drums were labeled and stored on pallets prior to off-site disposal.

An approved disposal facility will pick-up the drums for off-site disposal. BC will coordinate with the facility to arrange for the waste pick-up, and provide information regarding the drum inventory including waste characterization data.
