Second Half 2018
Semi-Annual Groundwater Monitoring Report
Patchogue Former MGP Site
NYSDEC Site No. 1-52-182
Village of Patchogue, Suffolk County, New York

Prepared for
National Grid USA
Hicksville, New York
March 2019

Project Number: 153021.780.005

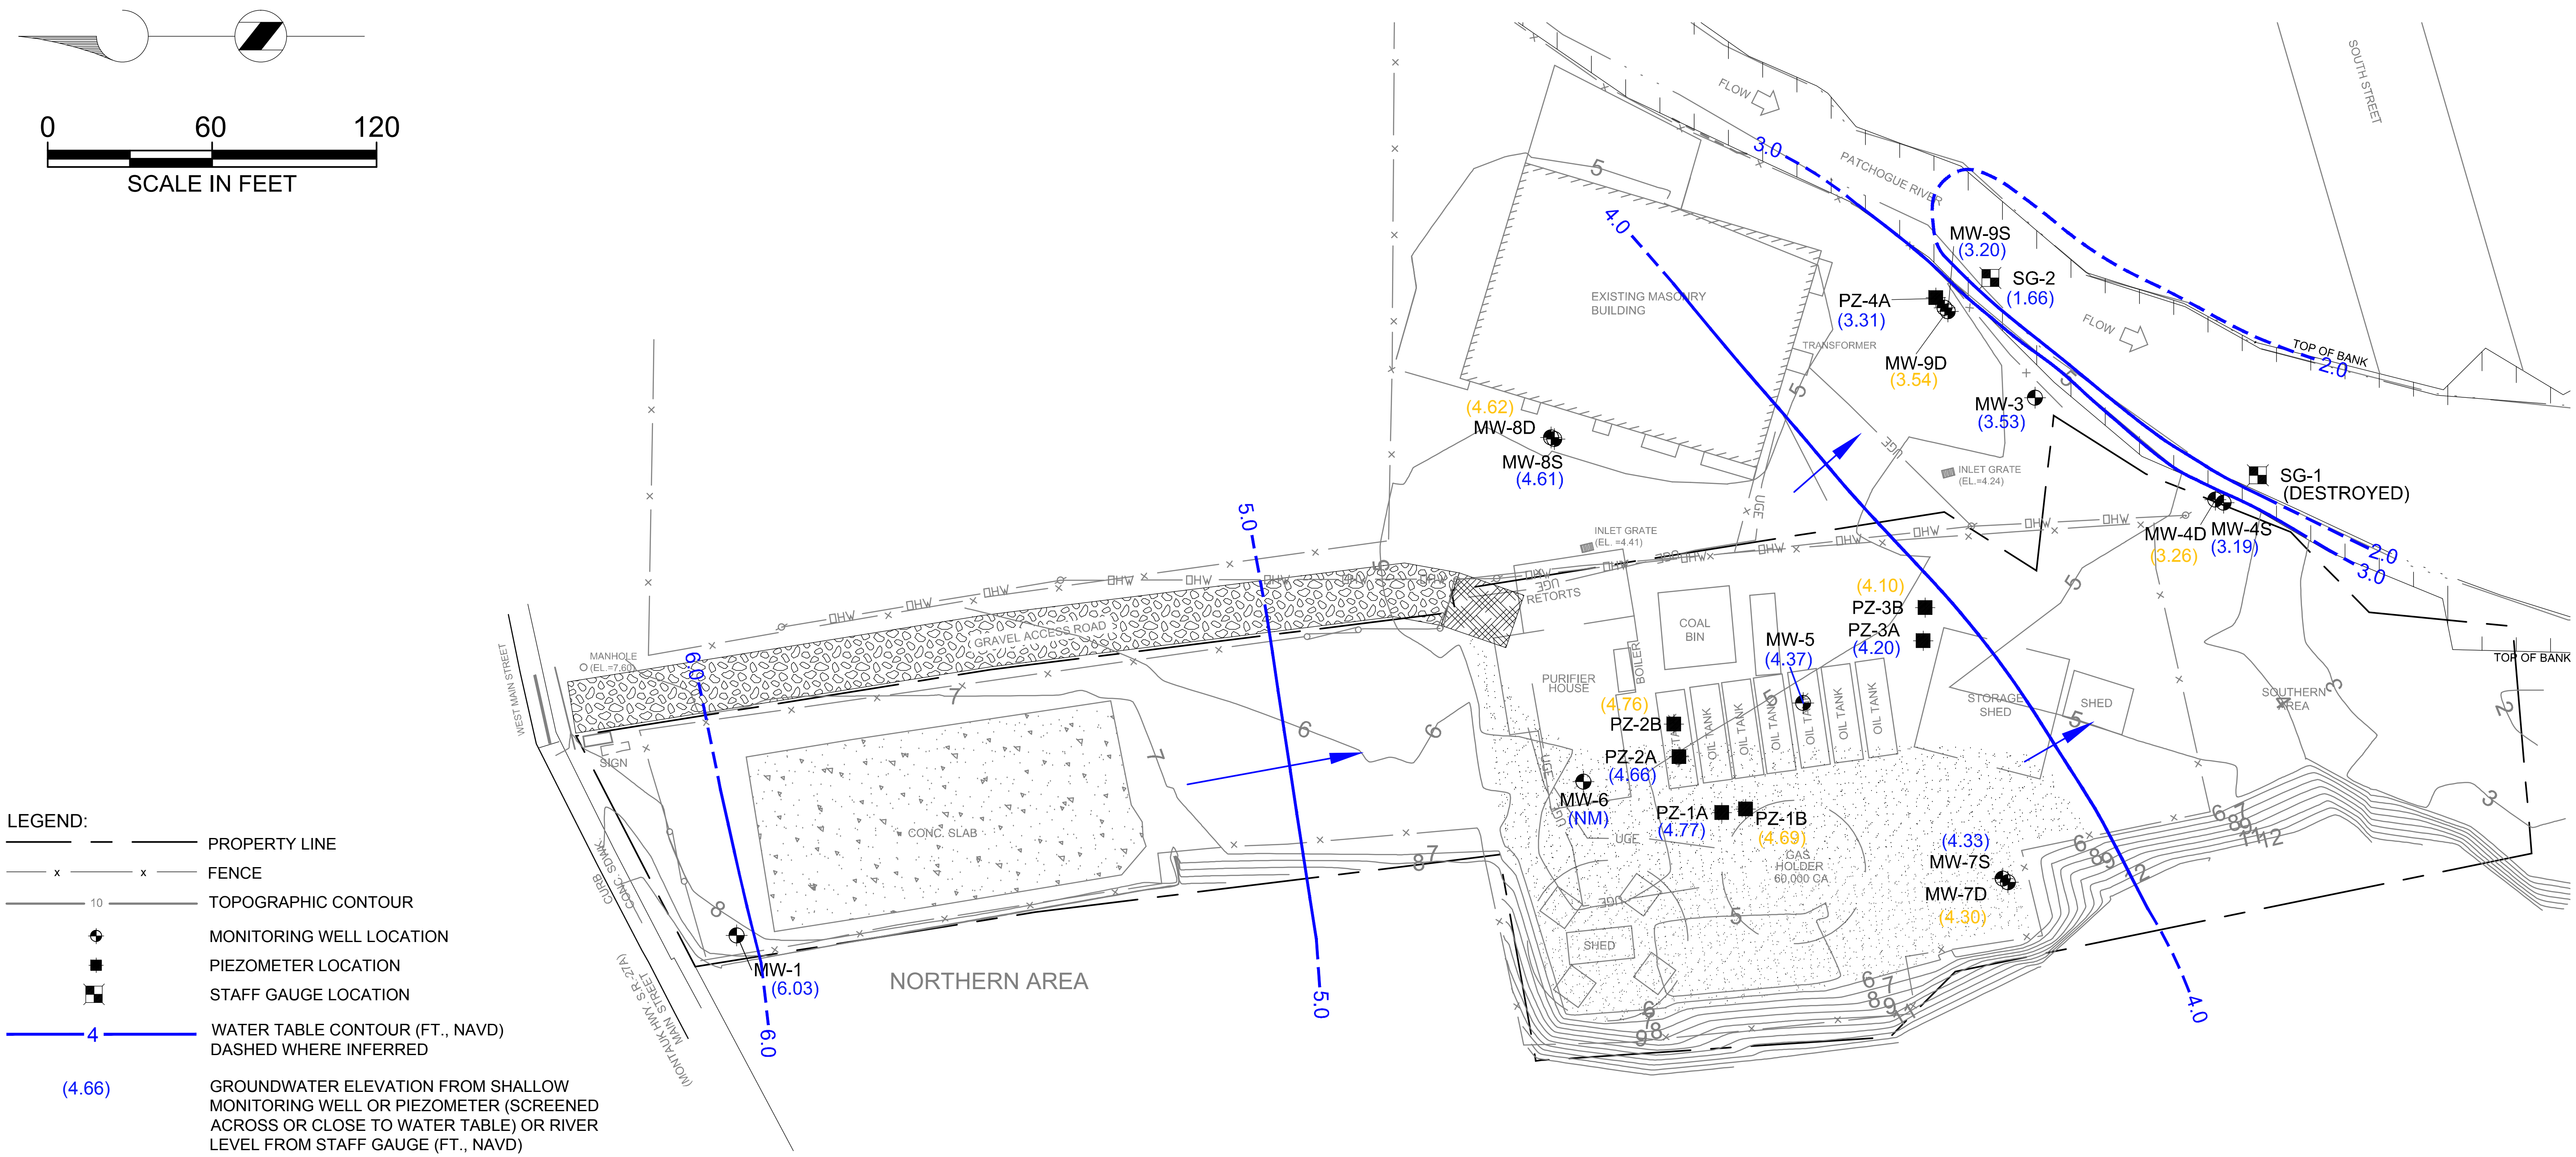
Brown AND Caldwell	SCALE: 1" = 60' 149322 DATE: January 3, 2019	NATIONAL GRID PATCHOGUE FORMER MGP SITE VILLAGE OF PATCHOGUE, NEW YORK	WATER TABLE ELEVATION CONTOUR MAP DECEMBER 11, 2018	FIGURE 1

Table 1 provides the water level data and calculated water elevations from the December 11, 2018 measurements. Figure 1 illustrates the elevation contours of the water table based on these data. The contours were developed using water level elevation data from the shallow monitoring wells and shallow piezometers at the Site (i.e., those with screens that straddle, or are just below, the water table) and one of the two surface water staff gauges (SG-2) in the Patchogue River. The surface water level was not measured at SG-1 and has been considered destroyed; the staff gauge will no longer be used as a surface water elevation control point. The water level elevations used for contouring are representative of water table elevations at the Site. The groundwater elevation (hydraulic head) values for the wells and piezometers screened in deeper intervals are also posted for reference on Figure 1. The water table is relatively shallow and is typically positioned in the fill that overlies the native alluvial deposits and outwash deposits. The water table contours indicate that lateral groundwater flow is from northwest to southeast across the Site toward the Patchogue River. Comparisons of the groundwater elevations in the monitoring wells to the river elevation, as measured at the staff gauges, demonstrate that groundwater elevations are higher than the river level indicating that groundwater is discharging to the Patchogue River. The upward vertical hydraulic gradient measured at well pairs adjacent to the river (well pairs MW-4S and MW-4D, and MW-9S and MW-9D) is indicative of a discharge area and provides further support to the conclusion that groundwater is discharging to the Patchogue River. The general configuration of the water table contours developed using the December 11, 2018 data, and the interpreted groundwater flow patterns, are consistent with those from previous rounds of water level measurements with one exception. The exception occurred during the March 2010 sampling event when the large-scale dewatering activities were being conducted on the WWTF site located east of the Site on the opposite side of the river (see discussion in Section 1.1). Operation of this dewatering system temporarily altered groundwater flow patterns and levels at the Site (see “Groundwater Monitoring Report, Second Semiannual 2010 Sampling Event” [GEI, November 2010]).
